**Flood Control Project Maintenance
Levee Inspections**
LMA District Cover Sheet
Spring 2012 Levee Inspection Results

City of Sacramento

Spring 2012 Levee Inspection Results

Waterway			Bank	Unit Miles
Unit No. 01 City of Sacramento			Left	3.63
	Spring (March - May)	Summer (June - August)	(September - November) Fall	Winter (December - February)
Unit Maintenance Rating (Fall Only)				
Date of Inspection	4/11/2012 - 4/11/2012			
DWR Inspector	John Williamson			
Accompanied By	Doug Henery City of Sacramento			
	Jeff Chase City of Sacramento			
	William Roberts City of Sacramento

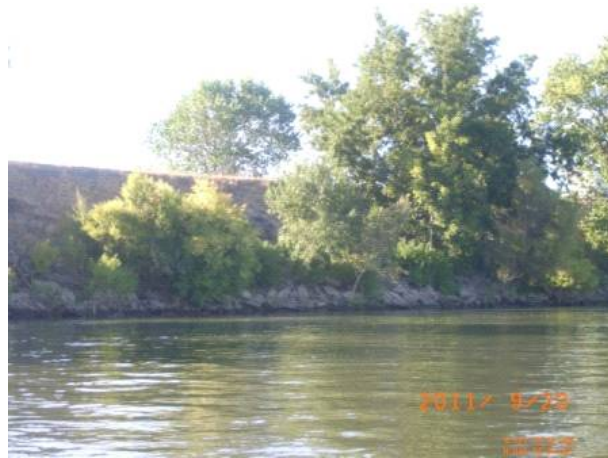
Levee Mile Report Line	1
Start Levee Mile	
End Levee Mile	
Location	Water Side
Category	Supplemental
Item	USACE Erosion Survey
USACE 2011 Photo #1	
johngw_s_20120313_145.jpg

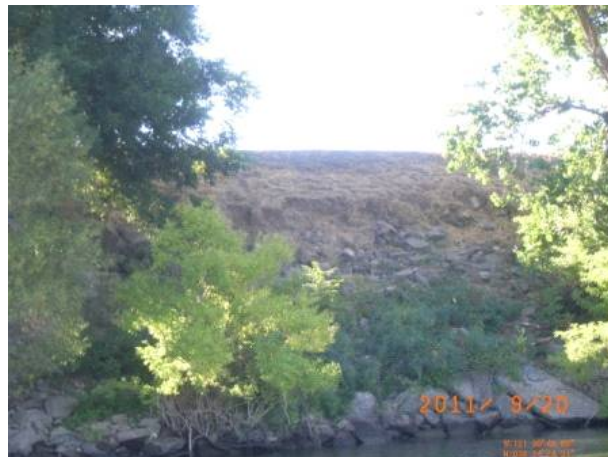
Levee Mile Report Line	1
Start Levee Mile	
End Levee Mile	
Location	Water Side
Category	Supplemental
Item	USACE Erosion Survey
USACE 2011 Photo #2	
johngw_s_20120313_146.jpg

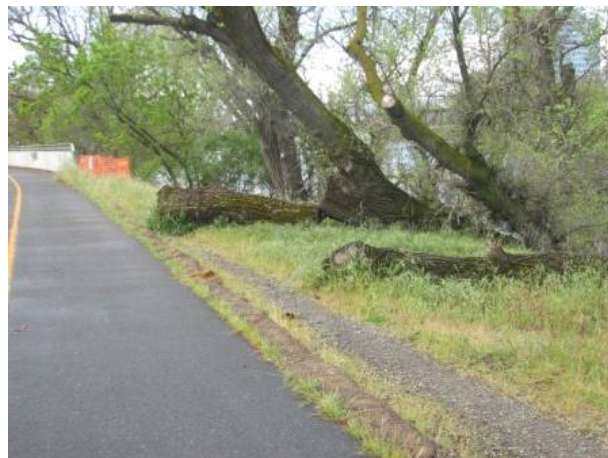
Levee Mile Report Line	6
Start Levee Mile	0.02
End Levee Mile	0.02
Location	Water Side
Category	Earthen Levee
Item	Encroachments
Fallen tree leaning against levee slope. No uprooting damage to slope, photo taken spring 2012.	
johngw_s_20120412_689.jpg

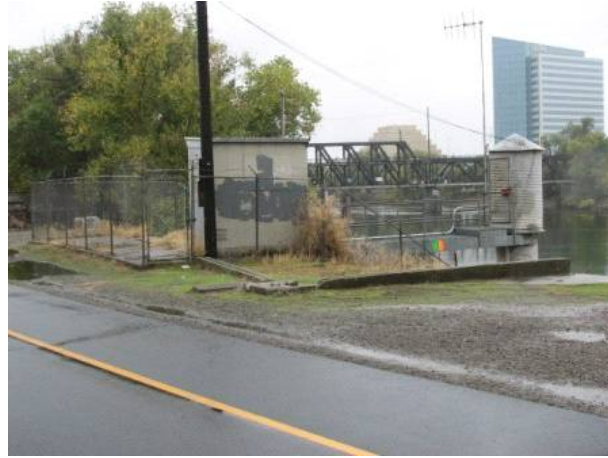
Levee Mile Report Line	7
Start Levee Mile	0.14
End Levee Mile	0.14
Location	Water Side
Category	Earthen Levee
Item	Encroachments

View of the I Street recorder can.

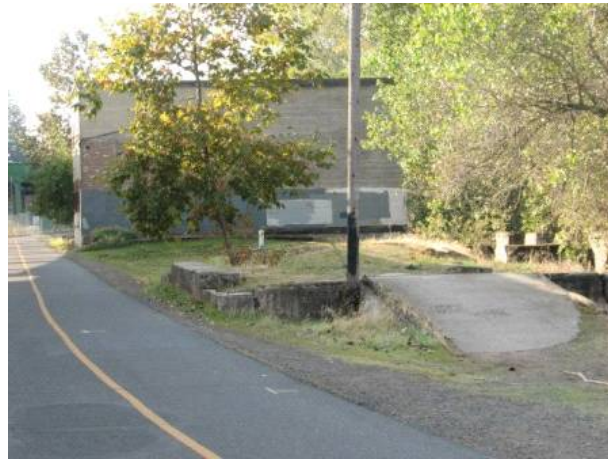
Levee Mile Report Line	8
Start Levee Mile	0.22
End Levee Mile	0.22
Location	Water Side
Category	Earthen Levee
Item	Encroachments

Historical Building with foundations and ramps on upstream and downstream sides. Fall 2011

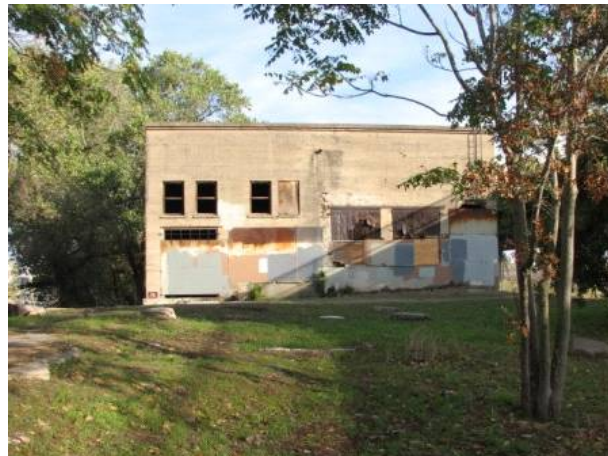
Levee Mile Report Line	8
Start Levee Mile	0.22
End Levee Mile	0.22
Location	Water Side
Category	Earthen Levee
Item	Encroachments

A view of the south side of the building. Fall 2011

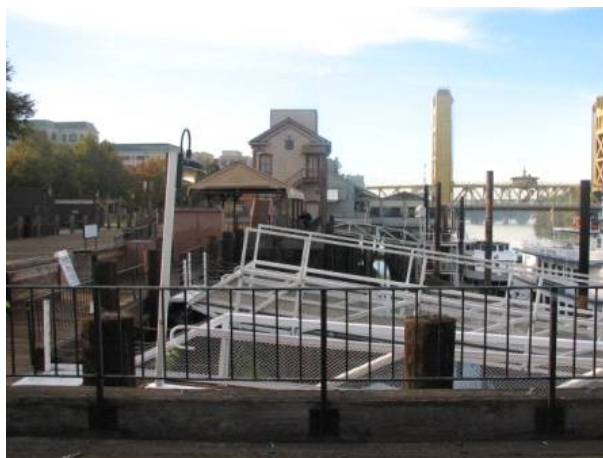
Levee Mile Report Line	9
Start Levee Mile	0.37
End Levee Mile	0.73
Location	Crown
Category	Earthen Levee
Item	Encroachments

Photo looking downstream from the Delta King in Old Sacramento.

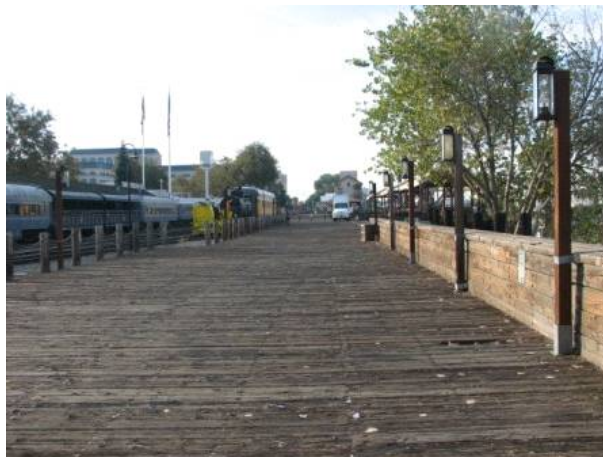
Levee Mile Report Line	9
Start Levee Mile	0.37
End Levee Mile	0.73
Location	Crown
Category	Earthen Levee
Item	Encroachments

The wooden board walk in Old Sacramento on top of the flood wall. Fall 2011

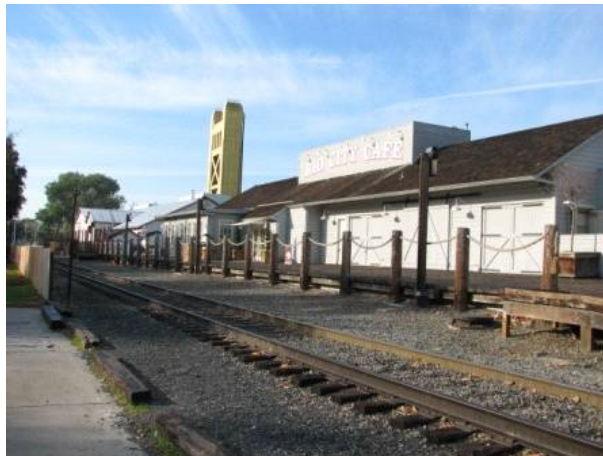
Levee Mile Report Line	9
Start Levee Mile	0.37
End Levee Mile	0.73
Location	Crown
Category	Earthen Levee
Item	Encroachments

The buildings are on top of the flood wall and extend out over the river. Fall 2011

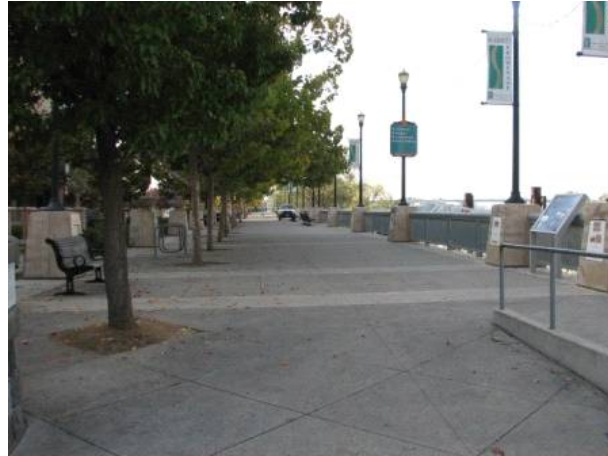
Levee Mile Report Line	10
Start Levee Mile	0.76
End Levee Mile	1.15
Location	Crown
Category	Earthen Levee
Item	Vegetation

The start of the river walk at Tower Bridge. Fall 2011

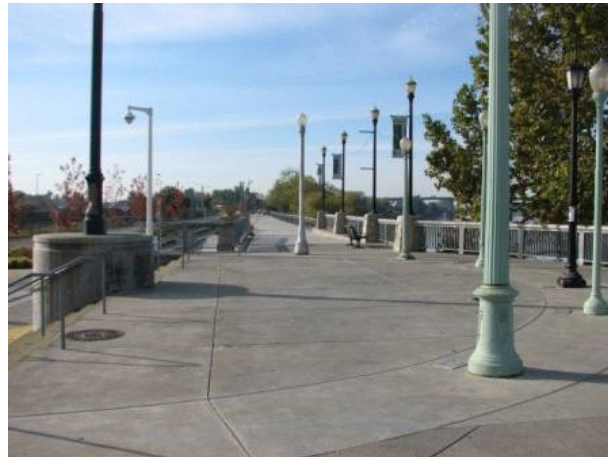
Levee Mile Report Line	10
Start Levee Mile	0.76
End Levee Mile	1.15
Location	Crown
Category	Earthen Levee
Item	Vegetation

The start of the newest extension of the river walk. Fall 2011

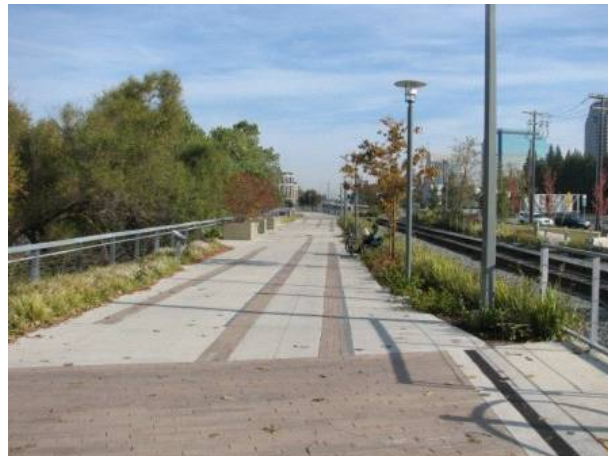
Levee Mile Report Line	10
Start Levee Mile	0.76
End Levee Mile	1.15
Location	Crown
Category	Earthen Levee
Item	Vegetation

The end of the river walk. This is where the bike trails turns off the levee. Fall 2011

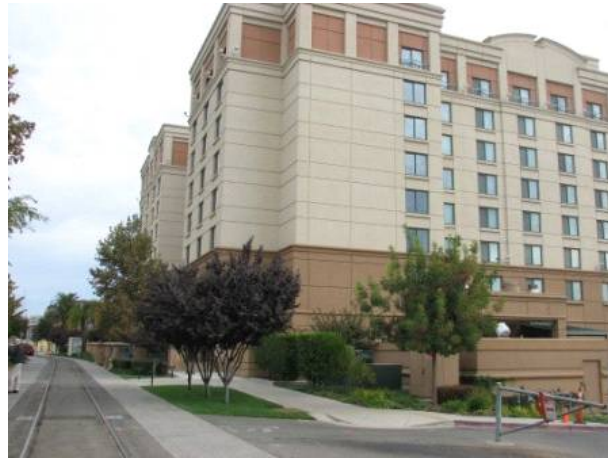
Levee Mile Report Line	11
Start Levee Mile	0.78
End Levee Mile	0.78
Location	Crown
Category	Earthen Levee
Item	Encroachments

Embassy Suites

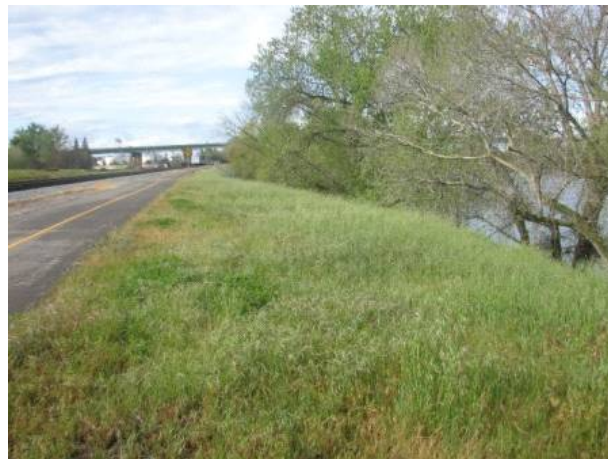
Levee Mile Report Line	12
Start Levee Mile	1.15
End Levee Mile	1.73
Location	Water Side
Category	Earthen Levee
Item	Vegetation

Waterside grasses taller than 12", photo taken spring 2012.

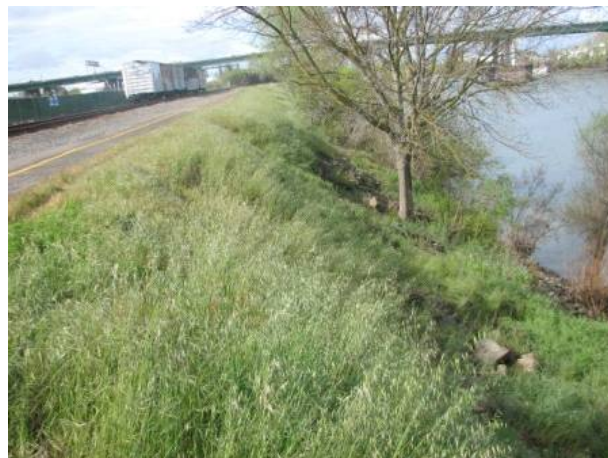
Levee Mile Report Line	13
Start Levee Mile	1.30
End Levee Mile	1.30
Location	Water Side
Category	Earthen Levee
Item	Erosion / Bank Caving

This is an erosion site within the USACE site, photo taken spring 2012.

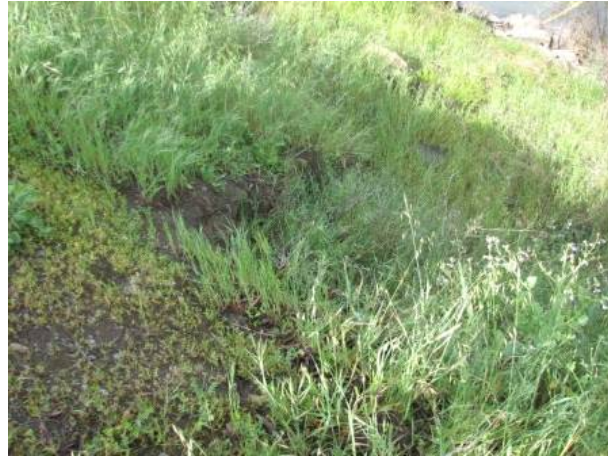
Levee Mile Report Line	13
Start Levee Mile	1.30
End Levee Mile	1.30
Location	Water Side
Category	Earthen Levee
Item	Erosion / Bank Caving

The erosion site at levee mile 1.27 is within the USACE site at 1.25-1.35, photo taken spring 2012.

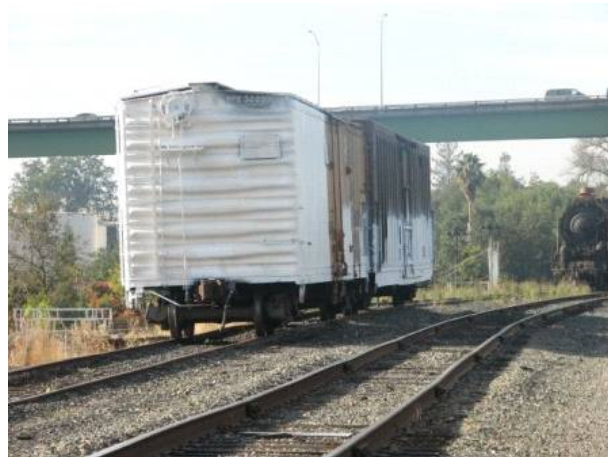
Levee Mile Report Line	14
Start Levee Mile	1.35
End Levee Mile	1.35
Location	Crown
Category	Earthen Levee
Item	Encroachments

This is the replacement of the storage bins on the railroad tracks.

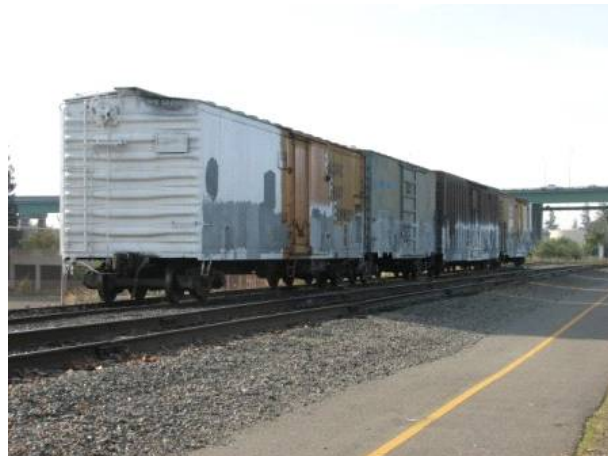
Levee Mile Report Line	14
Start Levee Mile	1.35
End Levee Mile	1.35
Location	Crown
Category	Earthen Levee
Item	Encroachments

There have been an additional two box cars added to this area. Fall 2011

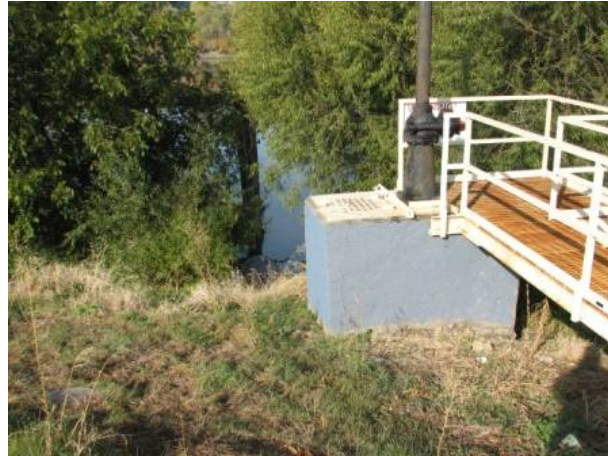
Levee Mile Report Line	15
Start Levee Mile	1.41
End Levee Mile	1.41
Location	Water Side
Category	Earthen Levee
Item	Encroachments

The screw gate is the positive closure for the pipe. Fall 2011

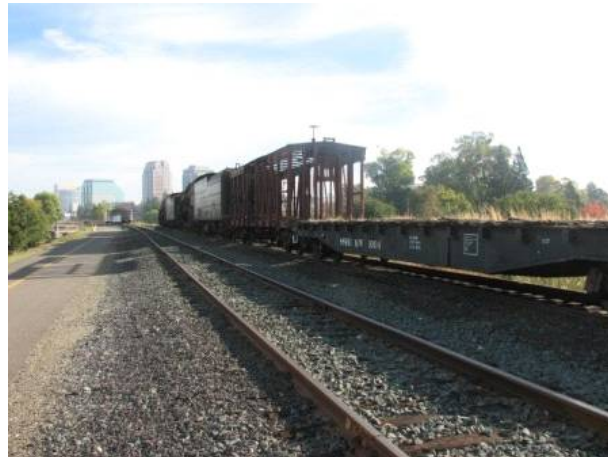
Levee Mile Report Line	16
Start Levee Mile	1.46
End Levee Mile	1.46
Location	Crown
Category	Earthen Levee
Item	Encroachments

16	1.46	1.46	Earthen Levee	Encroachments	CRA/W Ma	EQ : Equipment Inspector Comments: The trains have been moved upstream to this new location.	38.571477 ° -121.513744 °	38.571477 ° -121.513744 °	9 Y
							DWR ID: DWR_NA0005_01_s_2012_9		
17	1.73	1.96	Earthen Levee	Encroachments	CRA/W Ma	EQ : Equipment Inspector Comments: Levee is oversized with railroad tracks and paved parking. This area is Miller Park.	38.568172 ° -121.516042 °	38.564882 ° -121.516265 °	6 Y
							DWR ID: DWR_NA0005_01_s_2012_6		
18	1.75	1.75	Earthen Levee	Encroachments	CRA/W Ma	PI : Pipe	38.567821 ° -121.516091 °	38.567821 ° -121.516091 °	144 Y
							DWR ID: DWR_NA0005_01_s_2012_144		
19	1.96	2.34	Earthen Levee	Encroachments	CRA/W Ma	EQ : Equipment Inspector Comments: Railroad tracks run on crown of levee, paved roadway runs along toe on waterside. This is Miller Park Marina area.	38.564900 ° -121.516253 °	38.559460 ° -121.515085 °	7 Y

The trains that were at 1.54 have been pulled upstream to this location. The CVFPB has asked that they be removed from the levee.

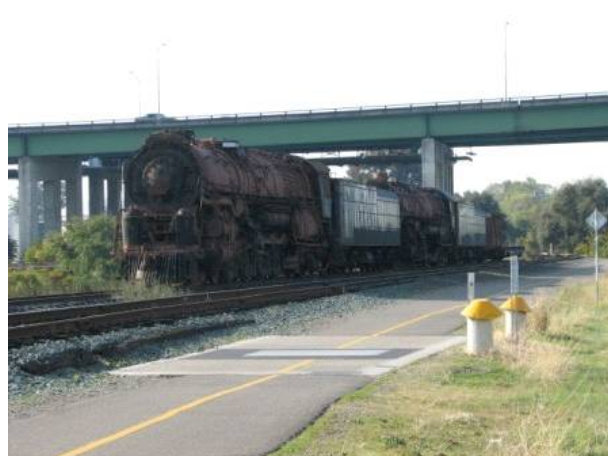
Levee Mile Report Line	16
Start Levee Mile	1.46
End Levee Mile	1.46
Location	Crown
Category	Earthen Levee
Item	Encroachments

The two steam engines and other cars are stored on the levee. There is an agreement being worked on with the Railroad Museum and the City. This is to have the cars moved when necessary. Fall 2011

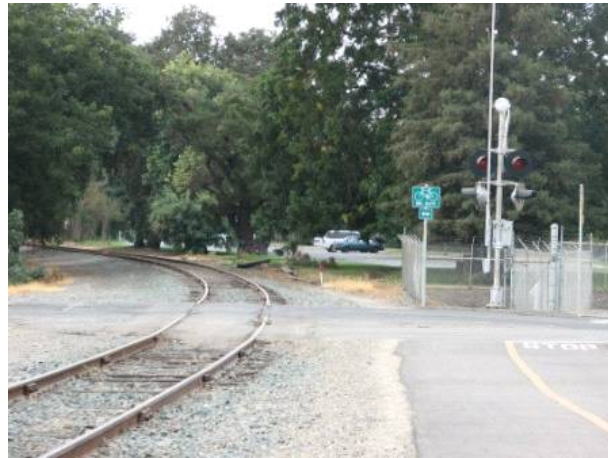
Levee Mile Report Line	17
Start Levee Mile	1.73
End Levee Mile	1.96
Location	Crown
Category	Earthen Levee
Item	Encroachments

Miller Park at Broadway, railroad track and parking area on levee.

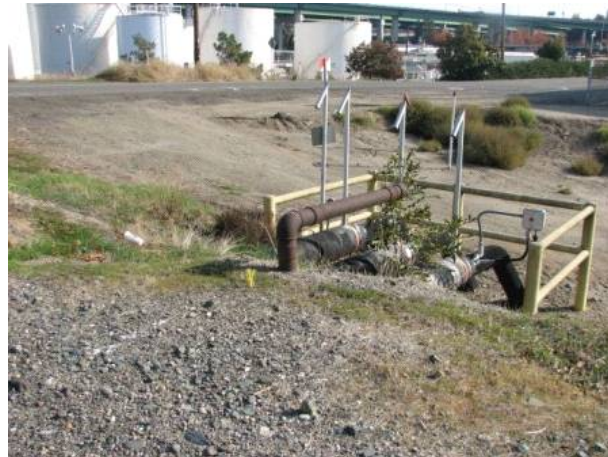
Levee Mile Report Line	18
Start Levee Mile	1.75
End Levee Mile	1.75
Location	Crown
Category	Earthen Levee
Item	Encroachments

A pipe on the landside shoulder crosses under the railroad tracks. Fall 2011

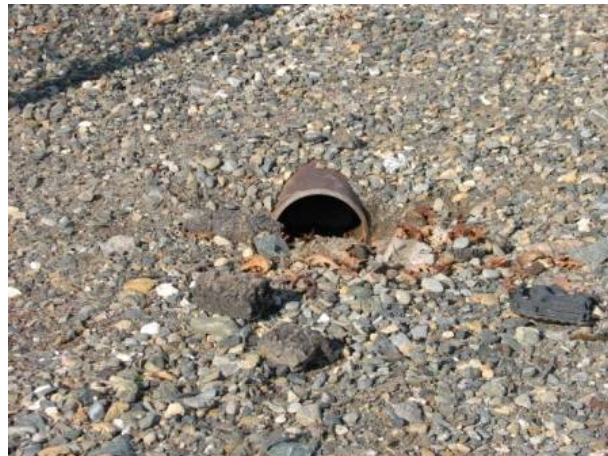
Levee Mile Report Line	18
Start Levee Mile	1.75
End Levee Mile	1.75
Location	Crown
Category	Earthen Levee
Item	Encroachments

This appears to be a drain pipe under a driveway. It is a different pipe than the other photo for this issue. Fall 2011

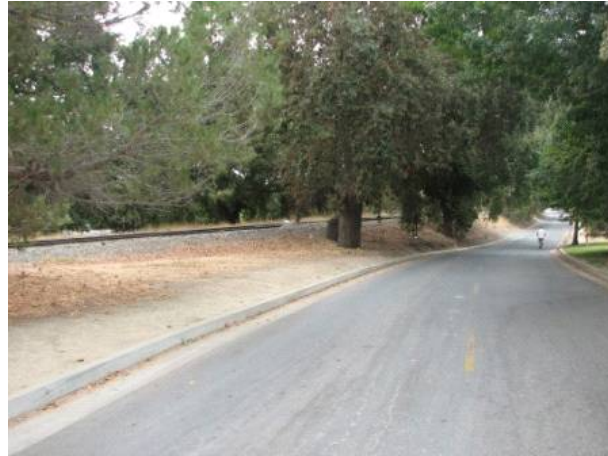
Levee Mile Report Line	19
Start Levee Mile	1.96
End Levee Mile	2.34
Location	Crown
Category	Earthen Levee
Item	Encroachments

Railroad tracks are on levee crown. The street is to the boat ramp.

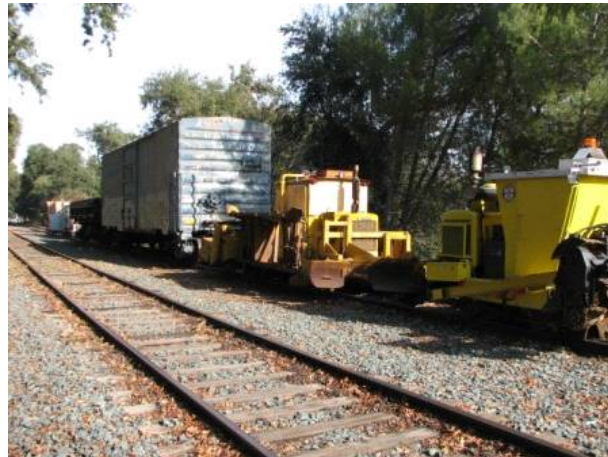
Levee Mile Report Line	19
Start Levee Mile	1.96
End Levee Mile	2.34
Location	Crown
Category	Earthen Levee
Item	Encroachments

The Railroad museum has moved the trains to this area along Miller Park. Fall 2011

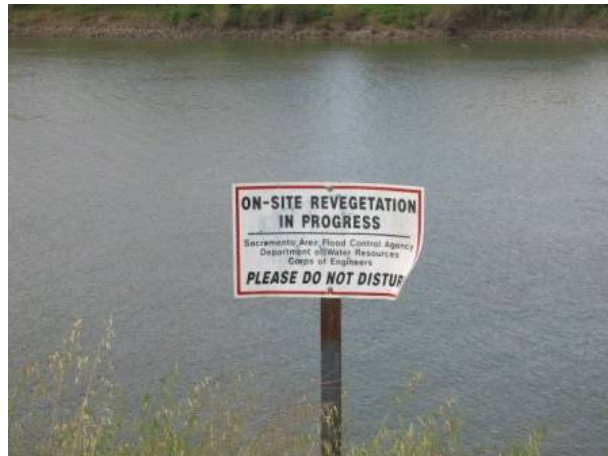
Levee Mile Report Line	24
Start Levee Mile	2.46
End Levee Mile	2.76
Location	Water Side
Category	Earthen Levee
Item	Vegetation

This area is a revegetation site, photo taken spring 2012.

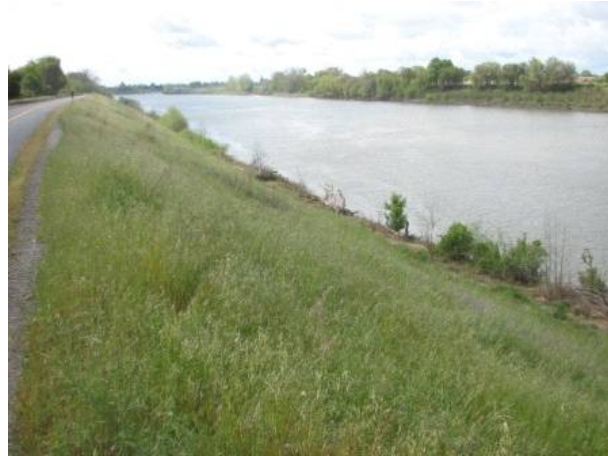
Levee Mile Report Line	24
Start Levee Mile	2.46
End Levee Mile	2.76
Location	Water Side
Category	Earthen Levee
Item	Vegetation

A photo of the revegetation site taken spring 2012.

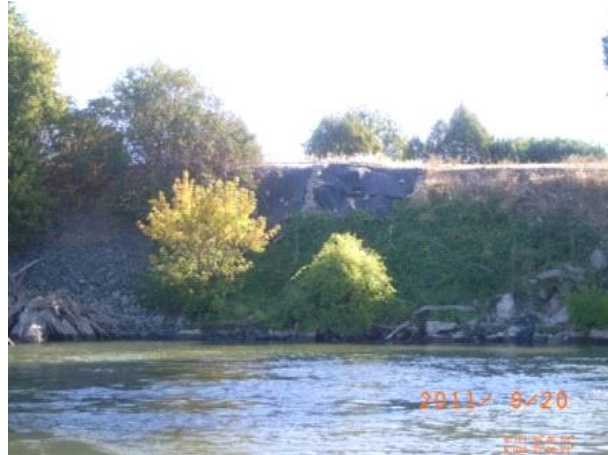
Levee Mile Report Line	25
Start Levee Mile	2.84
End Levee Mile	2.84
Location	Water Side
Category	Supplemental
Item	USACE Erosion Survey

USACE 2011 Photo #1

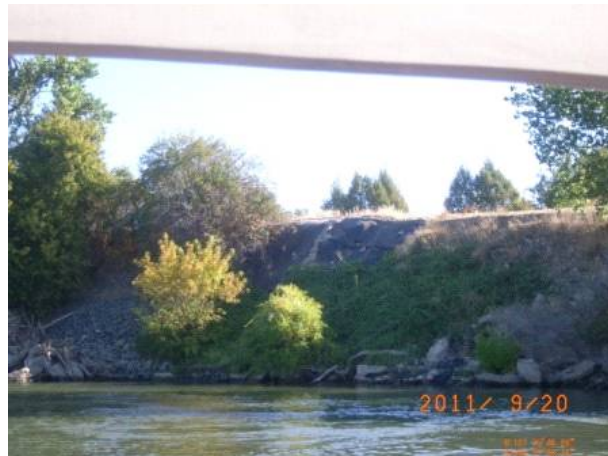
Levee Mile Report Line	25
Start Levee Mile	2.84
End Levee Mile	2.84
Location	Water Side
Category	Supplemental
Item	USACE Erosion Survey

USACE 2011 Photo #2

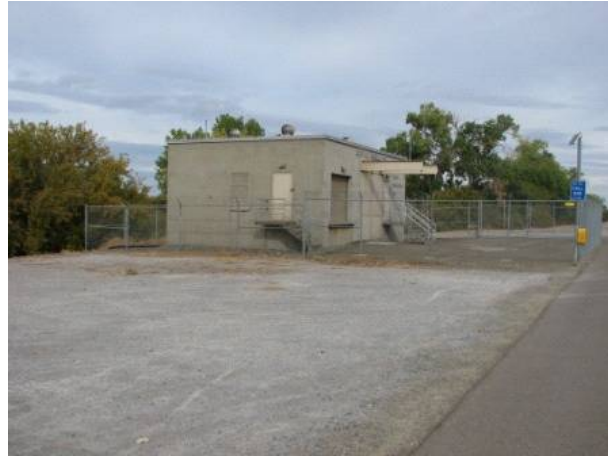
Levee Mile Report Line	26
Start Levee Mile	2.90
End Levee Mile	2.90
Location	Crown
Category	Earthen Levee
Item	Encroachments
City of Sacramento pump station on the waterside of the crown of the levee.	
johngw_s_20120313_144.jpg

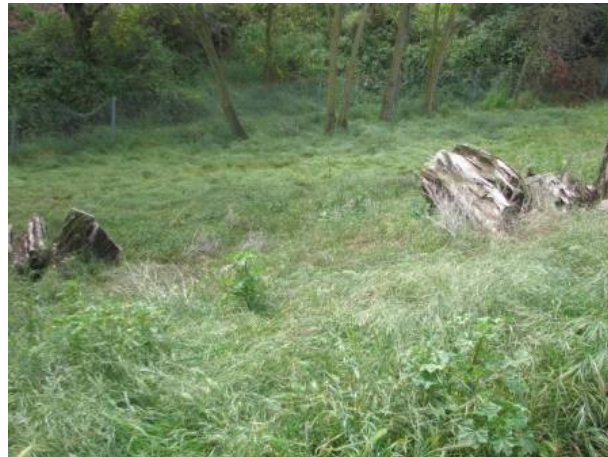
Levee Mile Report Line	27
Start Levee Mile	3.58
End Levee Mile	3.58
Location	Land Side
Category	Earthen Levee
Item	Trim / Thin Trees
The tree stumps are slowly decomposing and need to be removed, photo taken spring 2012.	
johngw_s_20120412_695.jpg
